STUDY OF THE CORROSION
OF LOCOMOTIVE BOILER TUBES

BY
C. C. CONGDON

ARMOUR INSTITUTE OF TECHNOLOGY
1915

A THESIS

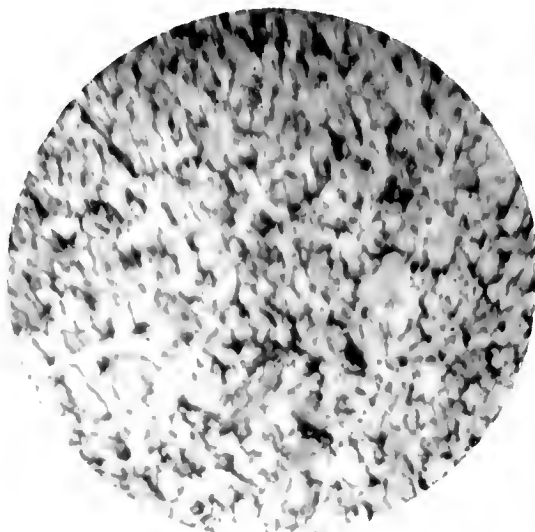
The above is a transverse section of a mild steel tube magnified 240 diameters. It shows clearly the ferrite grains.

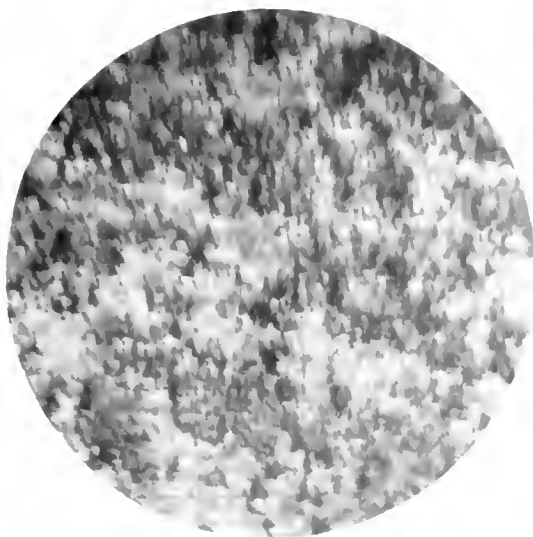
Magnification: 300 diameters. An oblique section of the metal. Light colored masses of ferrite clearly defined.
